# SHIVERS AND STUMBLES

# PUMPED OUT MPV

**VEHICLE:** 1993 Mazda MPV Van  
**POWERTRAIN:** 2.6L four-cylinder with four-speed automatic transmission  
**MILEAGE:** 112,842  
**COMPLAINT:** Intermittent hesitation and stalling.

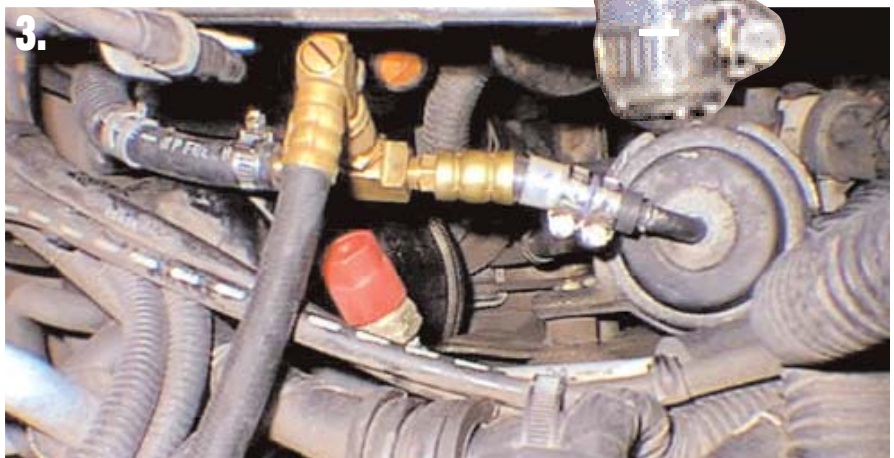
**3.** Having this adapter installed makes fuel pressure testing a snap. It would be nice if all cars had a Schrader valve built on the fuel line.

The Mazda 2.6 engine does not have a separate fuel tap or Schrader Valve connection. However, with our trusty master fuel pressure gauge kit, we can hook up a fitting that will allow us to “T” into the fuel system.

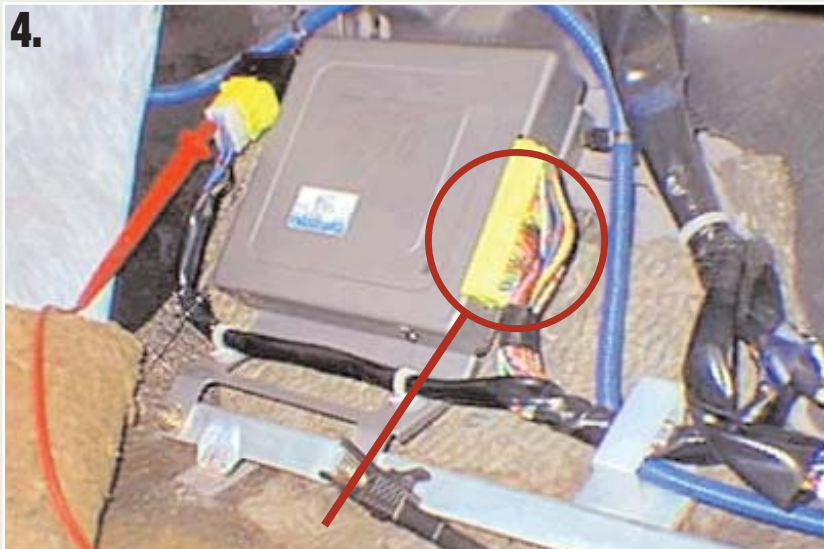
**4.** You can easily access the ECU and COR relay with the right front rug pulled back and the protection plate removed. You can see that I have back-probed the blue supply wire to the fuel pump.

on this van comes from the circuit opening relay (COR). The COR is mounted next to the engine ECU on the right front floor under the rug below a metal protection plate. The COR is a five-wire relay. The black wire is ground to the relay's coil when cranking. That same coil gets power from the starter circuit on the green/red wire during crank. The blue/green wire is ground for the relay's coil when running. That coil gets its power from the ECU on the black/white wire when tachometer signal is present for normal running. Finally, and most importantly, the solid blue wire sends power to the fuel pump when the relay contact closes.

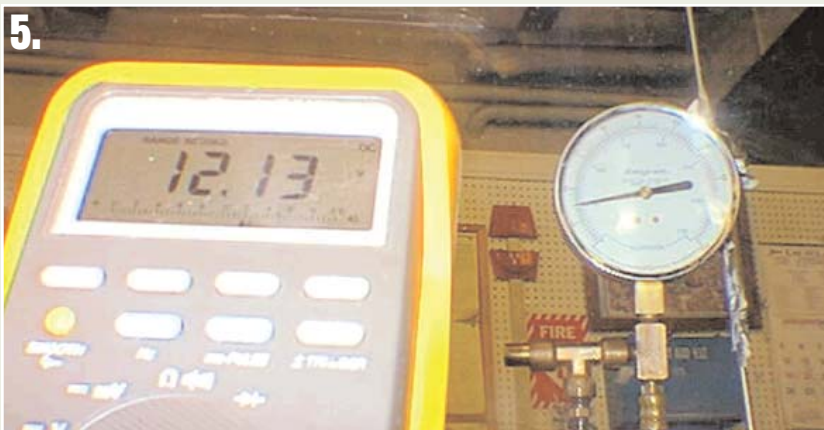
**5.** Finally the intermittent problem rears its ugly head. The fuel pump's supply voltage is solid and steady, but fuel pressure is taking a dive.

After another two test drives the car was finally hesitating. During these events, the fuel pressure dropped to 12 to 18 psi and the voltage to the pump remained a constant 12.4 volts. Even though all the variables had not been eliminated, our tests pointed to an intermittent fuel pump problem. Obviously, the best diagnostic test would be to hook up power and ground test leads as close to the pump as possible. A fuel pressure volume test and an amp draw test can be performed as well. Given a busy day's time constraints combined with this industry's escalating labor cost per hour, it is often more acceptable to perform tests at a remote, more accessible location, hence the method to my madness. As a final protective measure we installed a new fuel filter. It was a good thing we looked up the procedure to change the fuel pump; otherwise, we would have dropped the tank for nothing. As typical with Asian engineering, the pump access plate is located within the cabin under the #2 seat.

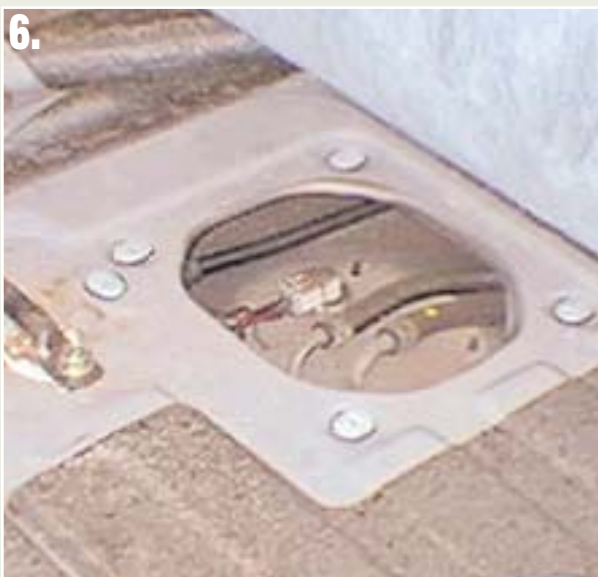
**6.** One of the easier fuel pump access locations in the normally difficult and complex world of automotive repair.

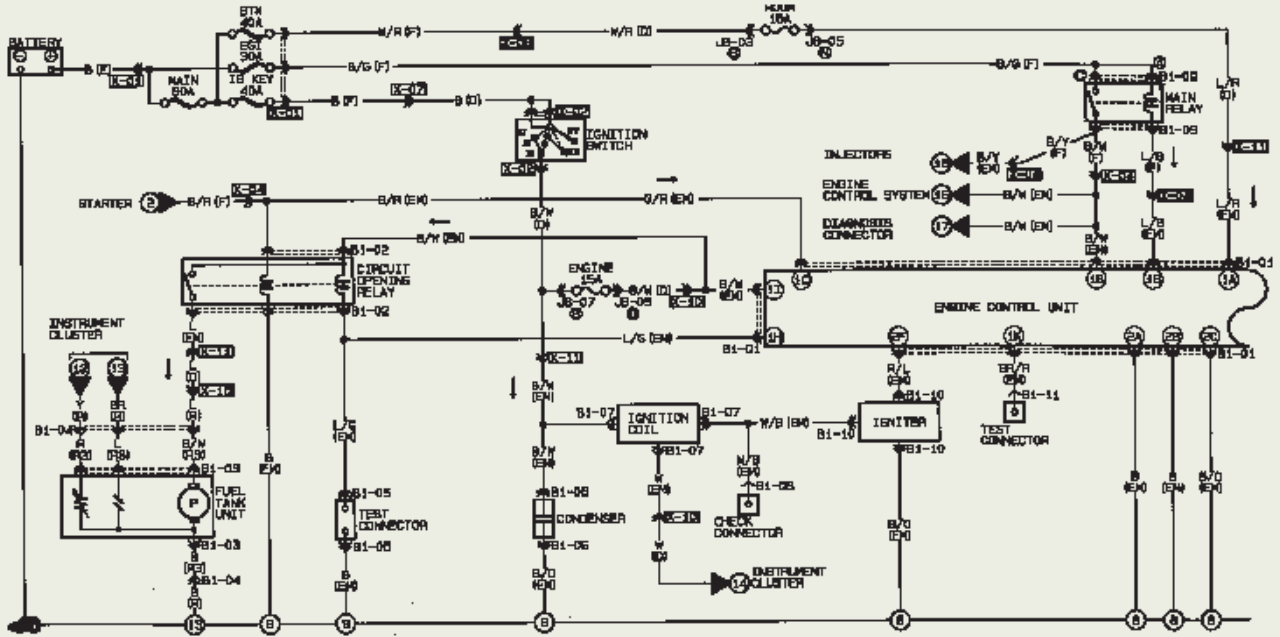
7. This is where it all happens. The wiring diagram shows the fuel pump circuit with connections to COR relay and ECU. (Illustration: ALLDATA)
