# SHIVERS AND STUMBLES

# PUMPED OUT MPV

**VEHICLE:** 1993 Mazda MPV Van  
**POWERTRAIN:** 2.6L four-cylinder with four-speed automatic transmission  
**MILEAGE:** 112,842  
**COMPLAINT:** Intermittent hesitation and stalling.

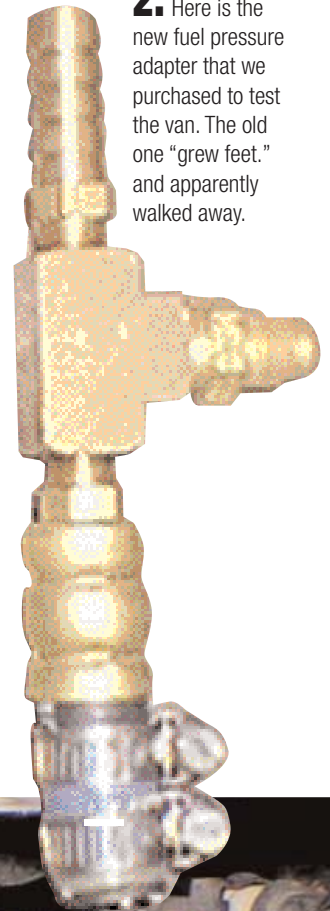
**2.** Here is the new fuel pressure adapter that we purchased to test the van. The old one "grew feet." and apparently walked away.
